Oxidizer Media Replacement Restores Performance

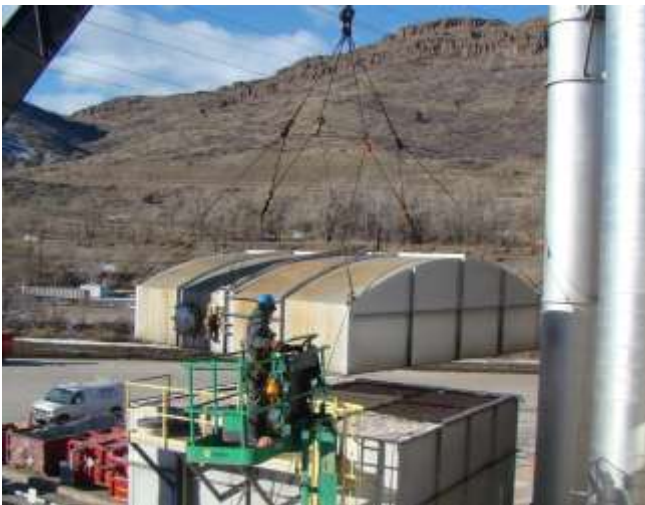
- The top of the RTO was cut off and lifted away using a crane in order to facilitate quicker removal of the existing ceramic media and to provide better access for necessary internal repairs.

PSSI led the turnkey project to supply new ceramic media, remove the existing media, install new media, oversee start-up of the Regenerative Thermal Oxidizer and organize disposal of the spent media. Crews worked around the clock to minimize the down-time and its associated impact on production. Work progressed as follows:

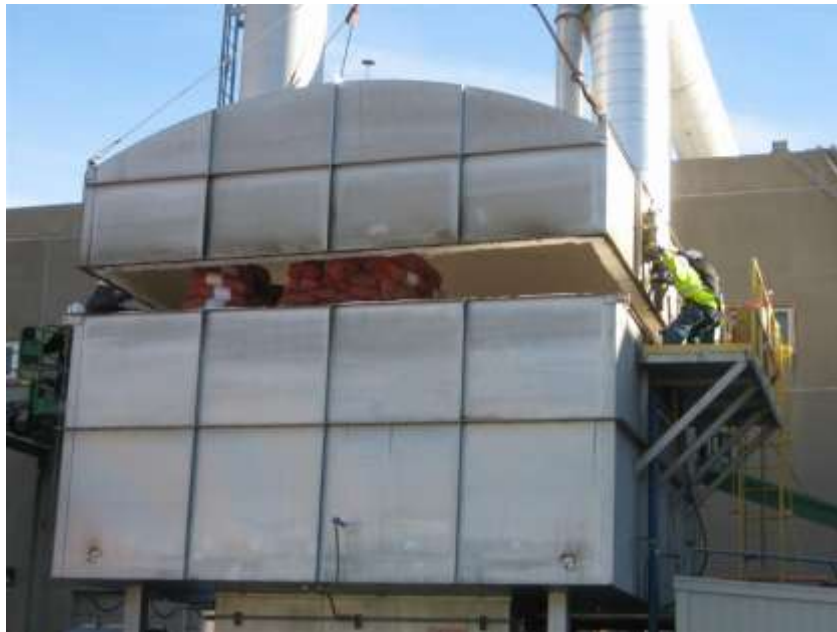
- The old stoneware was removed and stored in roll off bins until it could be analyzed and properly disposed.
- The existing support system and insulation were carefully examined for any signs of structural failure, degradation or media bypassing.
- Necessary repairs were made. Insulation was repacked around doors, openings, burners, etc.
- The new structured ceramic media was carefully and tightly repacked to the insulation in the chamber. Blocks of media were cut to the appropriate thickness to ensure a tight fit.
- The top was lifted and welded back in place.

- The site was cleaned, the refuse and old ceramic media were disposed, and the system was placed back in service.
