Oxidizer Media Replacement Restores Performance for Containers-Manufacturer

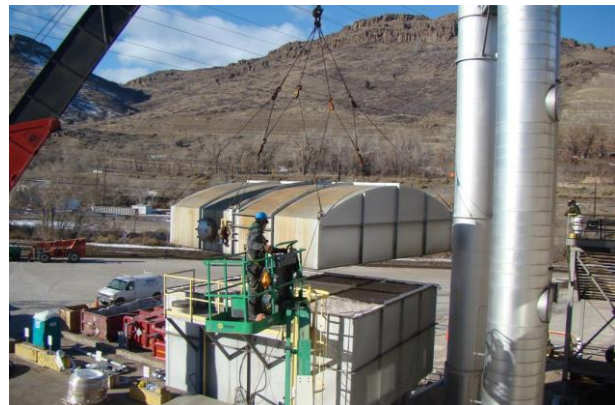
- The top of the RTO was cut off and lifted away using a crane in order to facilitate quicker removal of the existing ceramic media and to provide better access for necessary internal repairs.
- The old stoneware was removed and stored in roll off bins until it could be analyzed and properly disposed.
- The existing support system and insulation were carefully examined for any signs of structural failure, degradation or media bypassing.
- Necessary repairs were made. Insulation was repacked around doors, openings, burners, etc.
- The new structured ceramic media was carefully and tightly repacked to the insulation in the chamber. Blocks of media were cut to the appropriate thickness to ensure a tight fit.
- The top was lifted and welded back in place.
- The site was cleaned, the refuse and old ceramic media were disposed of, and the system was placed back in service.
