Pollution System Solutions

Media Replacement Restores Plant Capacity & Improves Flow

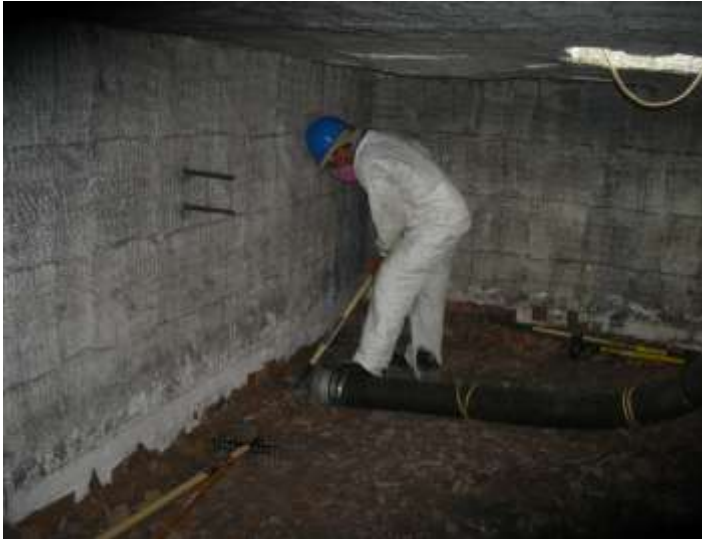
A recycling facility that processes waste bakery products was experiencing significant reductions in air flow capacity, thereby impacting production rates. The bottle neck was a 2 Chamber RTO system. Multiple bake-outs and even pressurized water washes of the media beds did not alleviate the high pressure drop issues.

Factors that caused the media beds to clog were particulate load in the airstream, ceramic media selections, and finally media installation arrangement. The original media used in the RTO was a combination of Lantec's MLM structured media and random ceramic saddles. A layer of random saddles was placed at the bottom of the chamber (cold face) followed by 5 feet of the MLM structured media and finally finished with top layer of random saddles.

Structured media are designed to handle high performance low pressure drops. However, introducing random saddles on the cold face subjects the incoming air stream to a high pressure drop layer before seeing the structured media. The impact of this random layer on the bottom is more severe than the layer at the top because the cold face is the lowest temperature region of the media chamber bed and is where most condensation and particulate clogging occurs. It is also the most difficult area to bake-out and clean. The top layer of random saddles is located near the very hot combustion chamber and therefore doesn't have the same concerns.

Upon removal of the layers of media, shards of the fractured MLM media could be found imbedded and trapped in the bottom layer of random saddles. This further aggravated the clogging issues and helps explain why bake-outs were so unsuccessful.

Pollution System Solutions Inc. (PSSI) resolved the air flow capacity issue by eliminating the bottom layer of random saddles and implementing 5 feet of a new high grade structured media directly on the cold face. The new media has larger void openings and is more resistant to clogging. Air flow through the RTO no longer hinders the upstream manufacturing process.

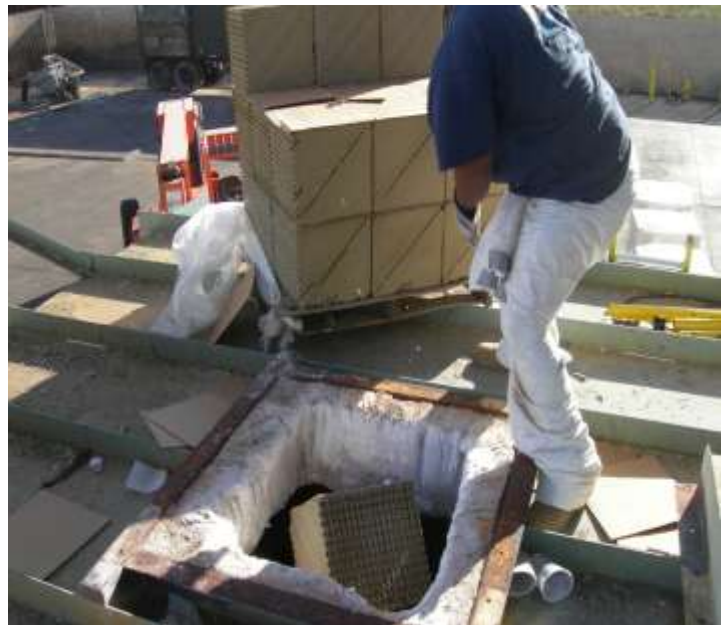
PSSI worked around the clock in 12 hour shifts for media removal and replacement to minimize impact of down time. Additionally, PSSI's experienced field service staff were able to address the customer's concern of extremely long start-up times, historically on the order of 20+ hours.

Previously, the manufacturer of the RTO stated to the customer that the long start-up times were due to a limitation of the burner in the unit. PSSI reviewed the current start-up procedure, made quick adjustments to some process parameters and controls, and the RTO came up to temperature within 3 hrs.
